# JOHN DAY RIVER SUBBASIN FISH HABITAT ENHANCEMENT PROJECT

## ANNUAL REPORT 1991

Oregon Department of Fish and Wildlife  
John Day, OR

Project Number 84-21  
Contract Number DE-A179-84BP 17460

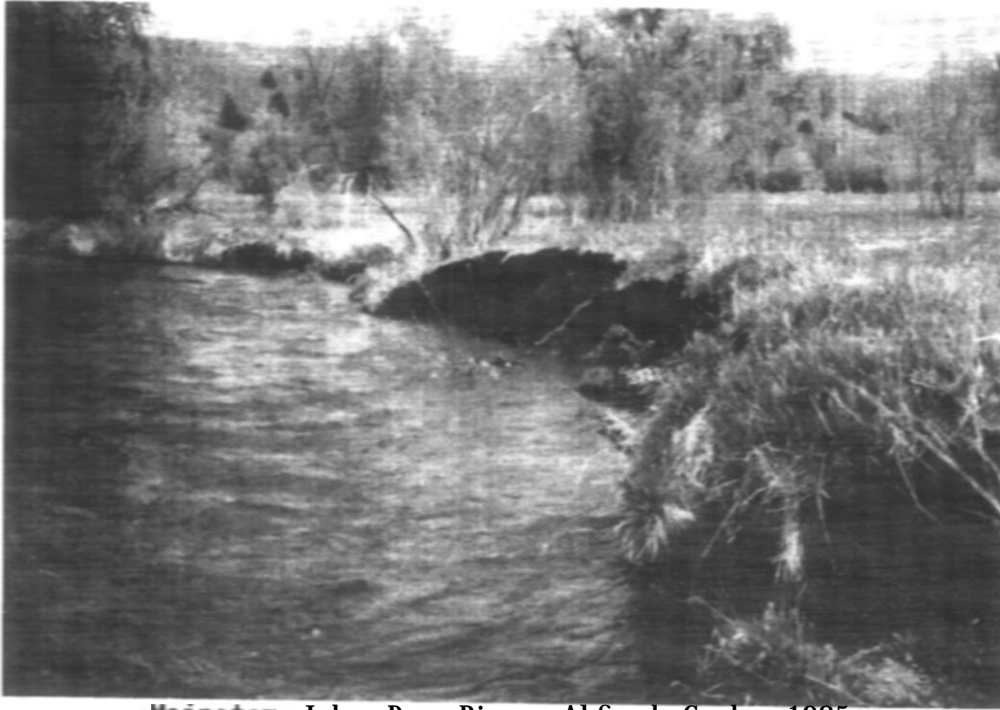
**Mainstem John Day River Alfred Combs 1985**

The top photo shows a cut bank eroded during spring flows within our Spring Chinook spawning grounds. This **eroded sediment later settles** upon the **salmon redds** and smothers the eggs.

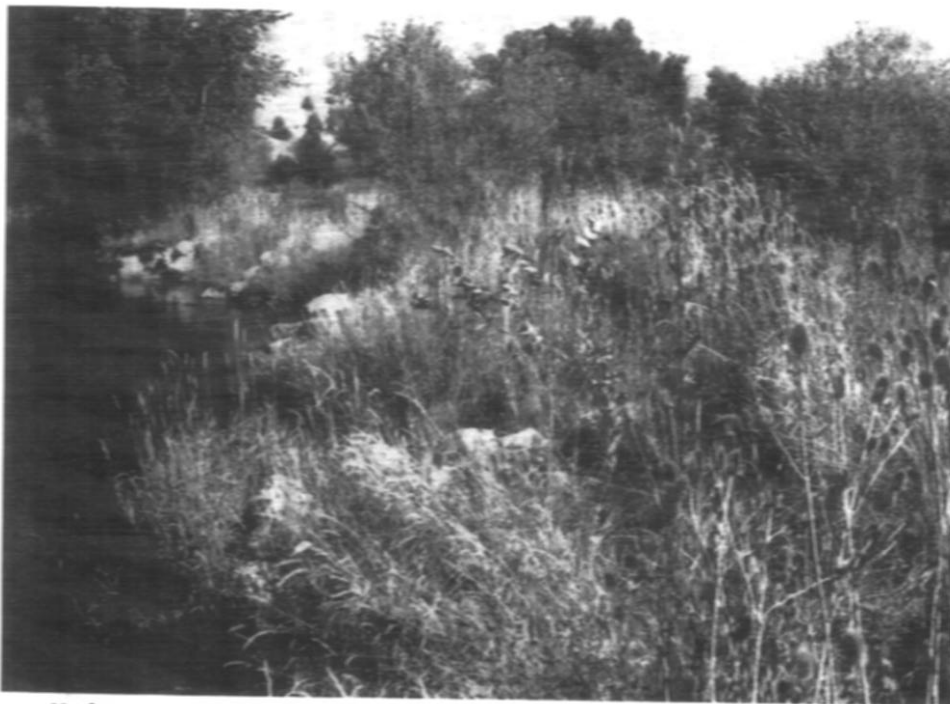
**Mainstem John Day River Alfred Coombs Property 1991**

The bottom photo shows how erosion control structures and livestock exclosure fences were used to end the bank cutting, provide deep pools, and create more fish rearing habitat. Vegetation is recovering quickly. This will eventually shade the river, provide organic **input**, and help stabilize the bank for many years. **Note** how our rock structures have **silted in**, and are being incorporated into the stream bank.

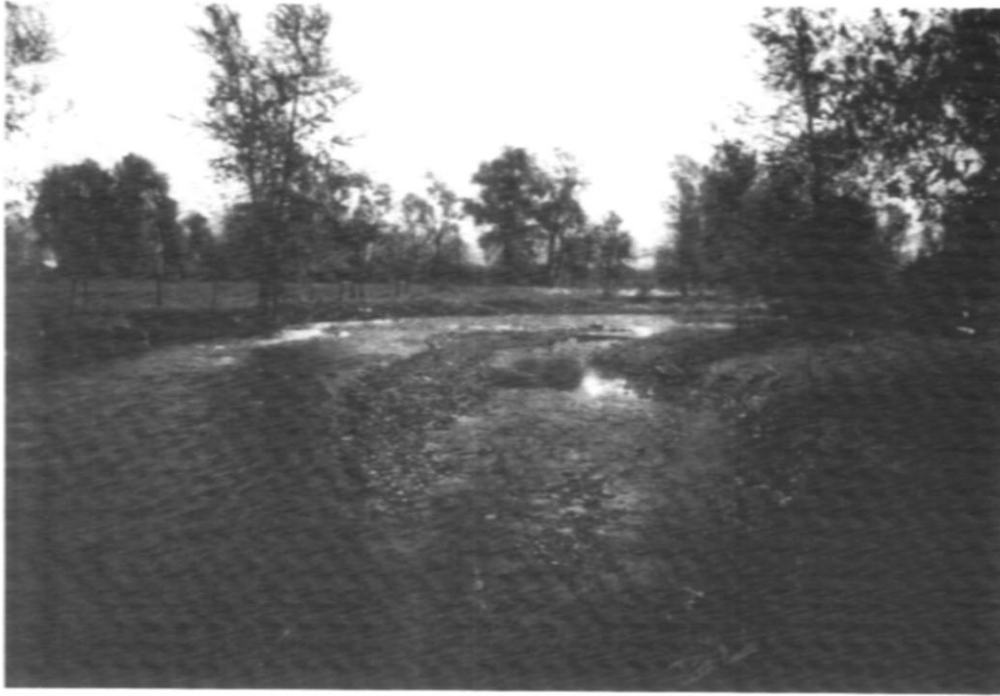
Mainstem John Day River Alfred Coombs Property 1985

The top photo shows a wide shallow stream with eroding banks and only a small amount of fish cover. The bottom photo shows the result of 6 years of recovery after the installation of jetties, boulders, and livestock exclosure fence. The banks have stopped eroding, the channel has narrowed and deepened. Fish cover has greatly increased, the vegetation boomed without livestock pressure. Note the small **woody** vegetation in the foreground that will soon provide shade and fish habitat to the stream.

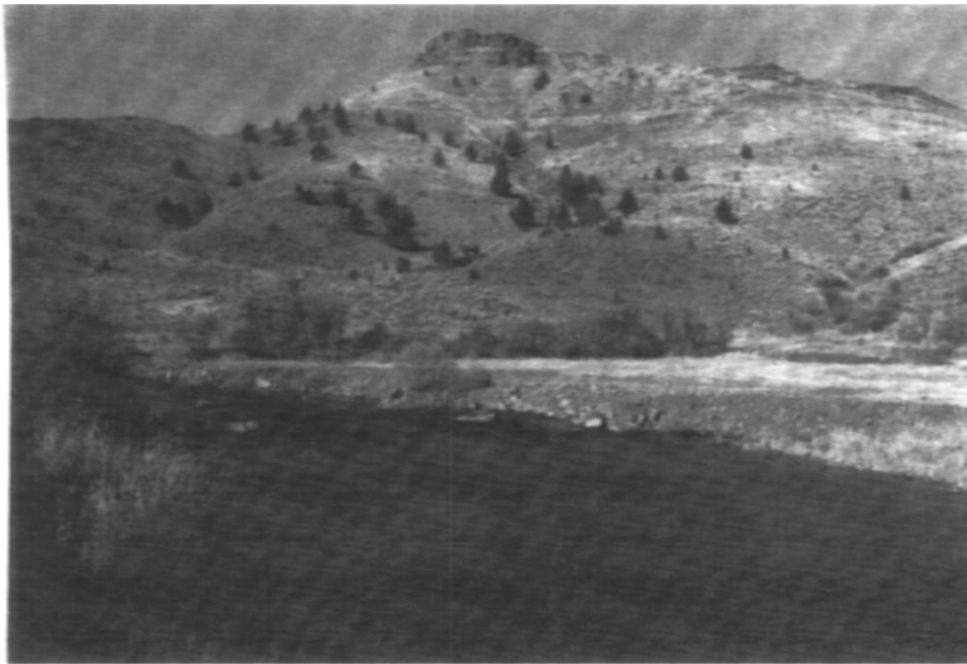
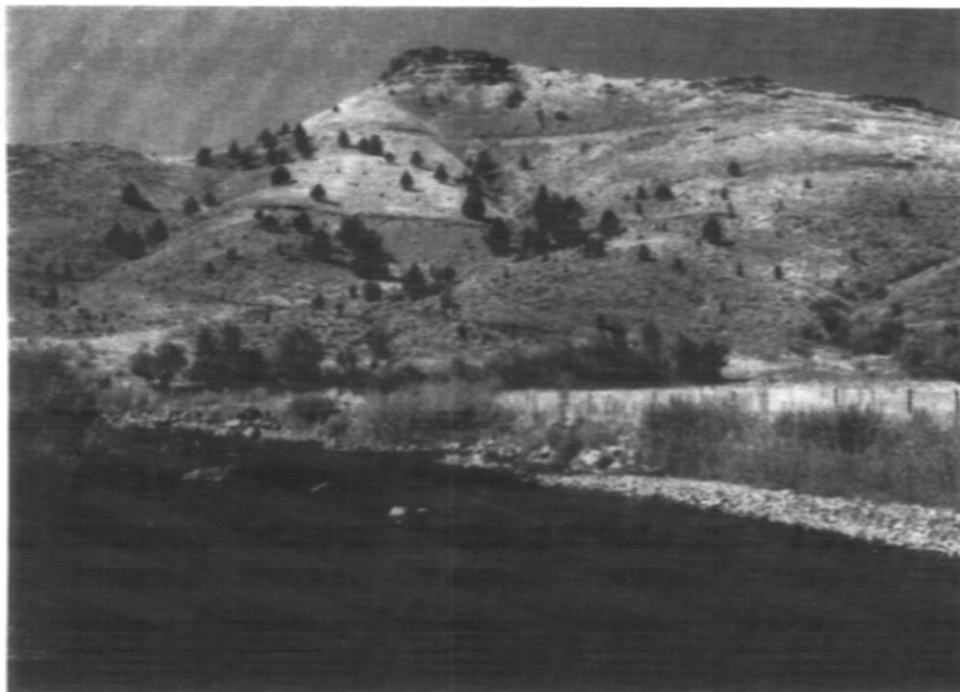
**Manistem John Day River. Neal Dow Property. 1987**

This area **shows** deposition and vegetative recovery that has occurred over the last 4 years.

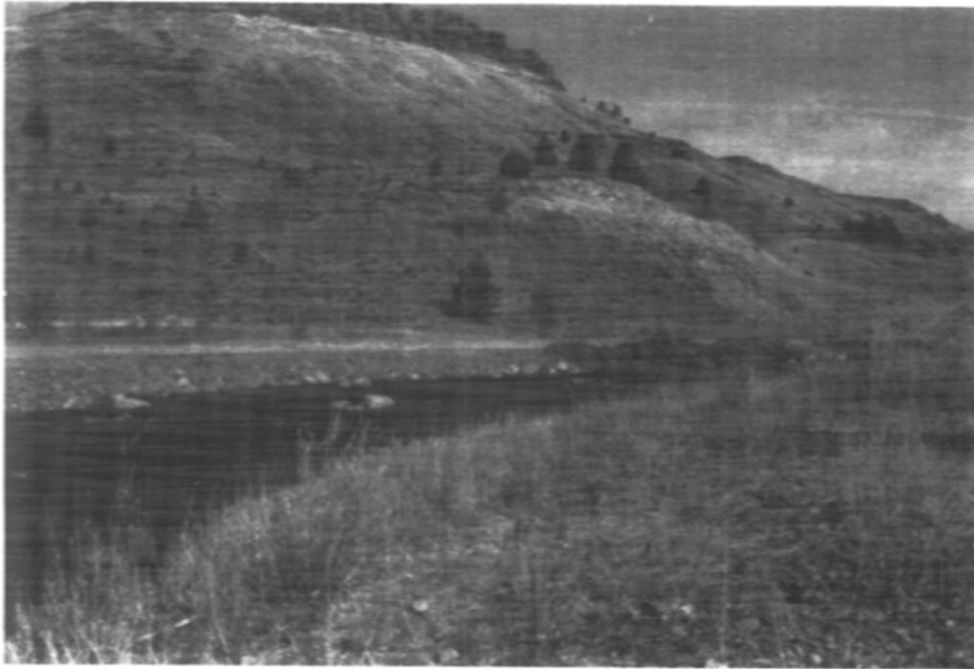
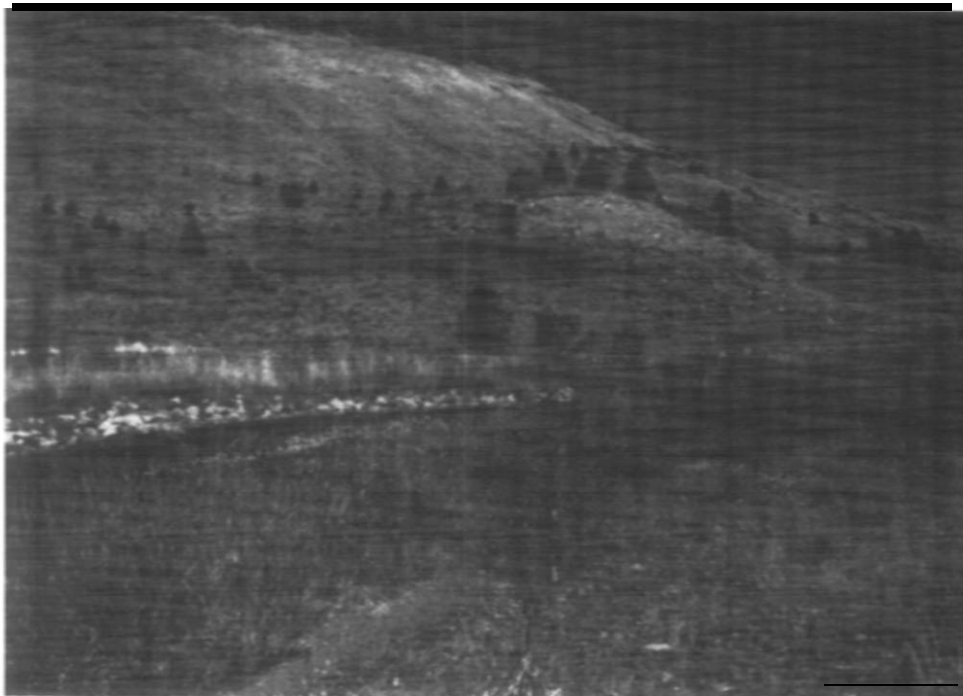
Mainstem John Day River. Neal Dow Property. **1987**

Here is an area that was riprapped on the far bank with a combination of rock structures and juniper structures. The bottom photo was taken 4 years later.

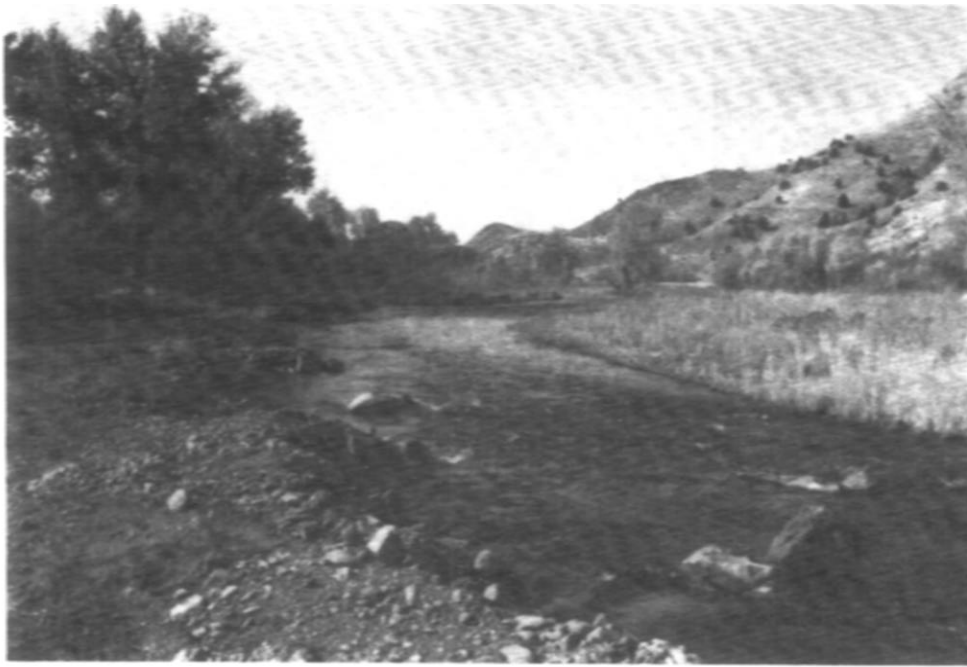
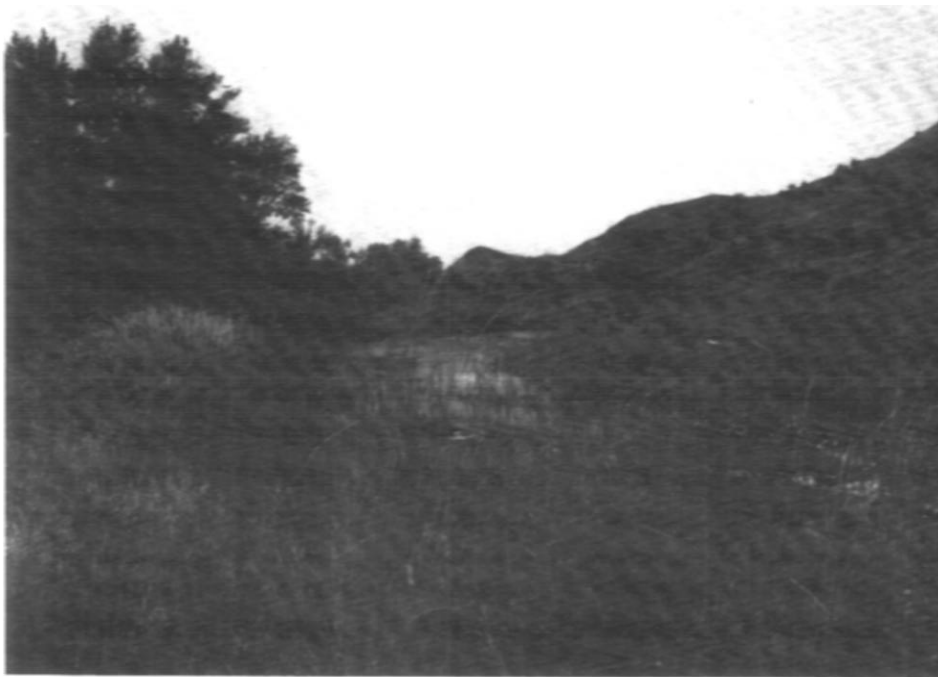
**Mainstem John Day River. Neal Dow Property. 1987**

The top photo shows this area shortly after jetty construction and boulder placement. This area had begun a recovery but a severe flood came through May of this year. The bottom photo was taken 3 months after this flood. Notice the bedload deposition on the right bank that buried a lot of new vegetation. This deposition is how banks are built and how the river becomes narrower and deeper.

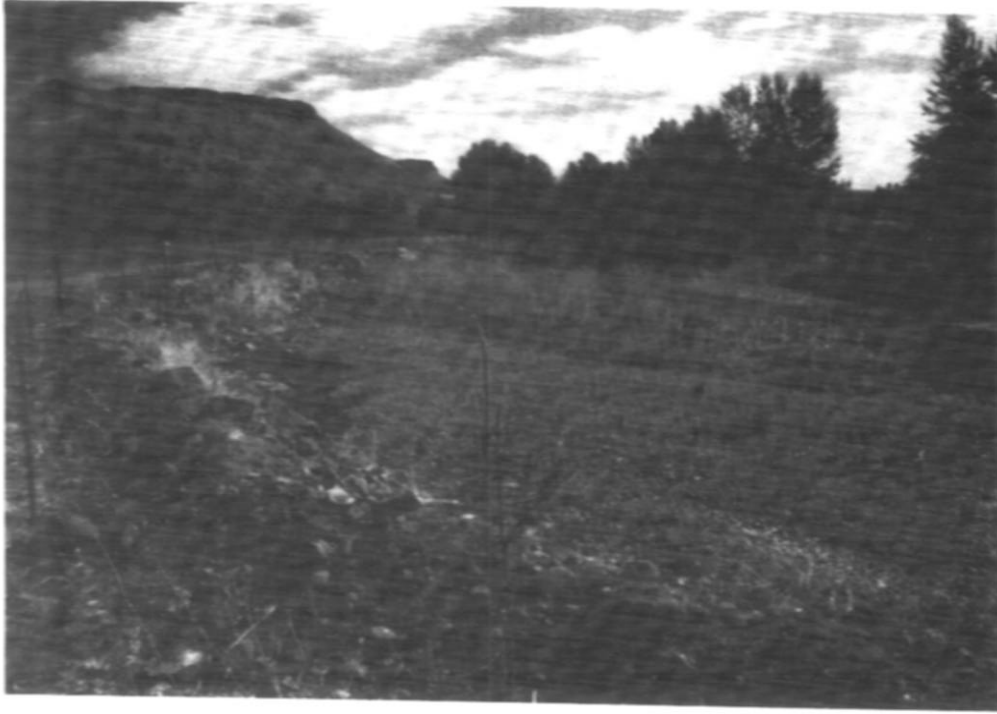
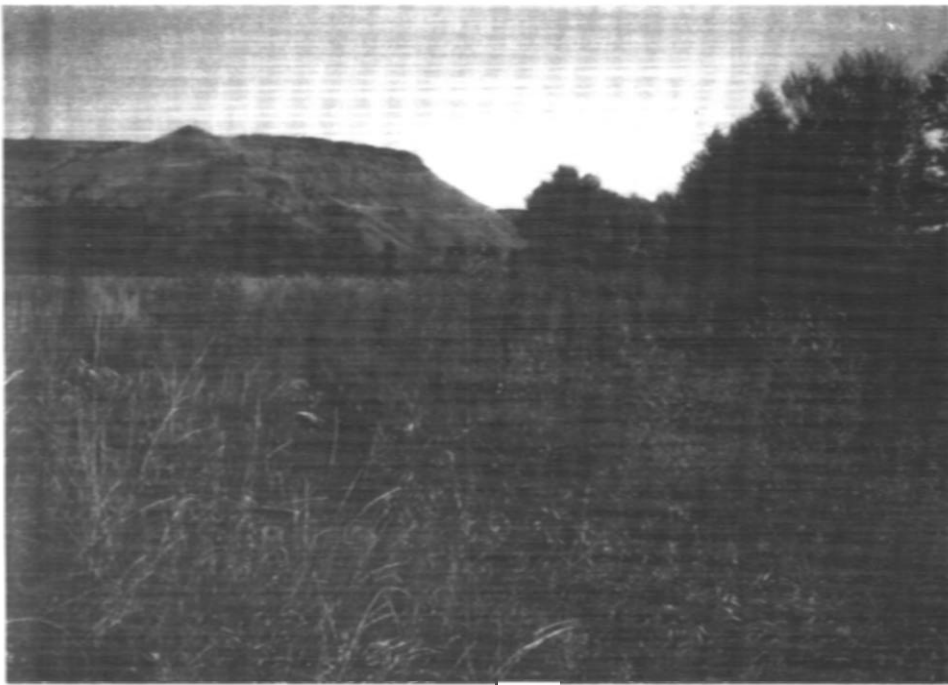
Mainstem John Day River. Donna Holmstrom Property. 1985

The top photo shows a large gravel bar with little vegetation. Stream channel is wide and shallow, providing little fish habitat. It also shows the landowner's attempts to prevent erosion. The bottom photo shows a new riparian exclosure fence and riprapped bank, with the results of 6 years of livestock exclusion and erosion control structures.
